DAMAGE TO WOODEN HOUSES AND HUMAN BEINGS BY THE 1978 MIYAGIKEN-OKI EARTHQUAKE IN SENDAI CITY

Iware MATSUDA, Toshio MOCHIZUKI*,
Michio MIYANO** and Toshikazu KOIZUMI*

Abstract Damage caused by the 1978 Miyagiken-Oki Earthquake was investigated in Sendai City. Geomorphological conditions well explained the distribution of the maximum horizontal acceleration and the damage to wooden houses. The number of the injured was expressed by a function of the number of damaged wooden houses. These results showed that a geomorphological land classification map is useful for a seismic microzoning.

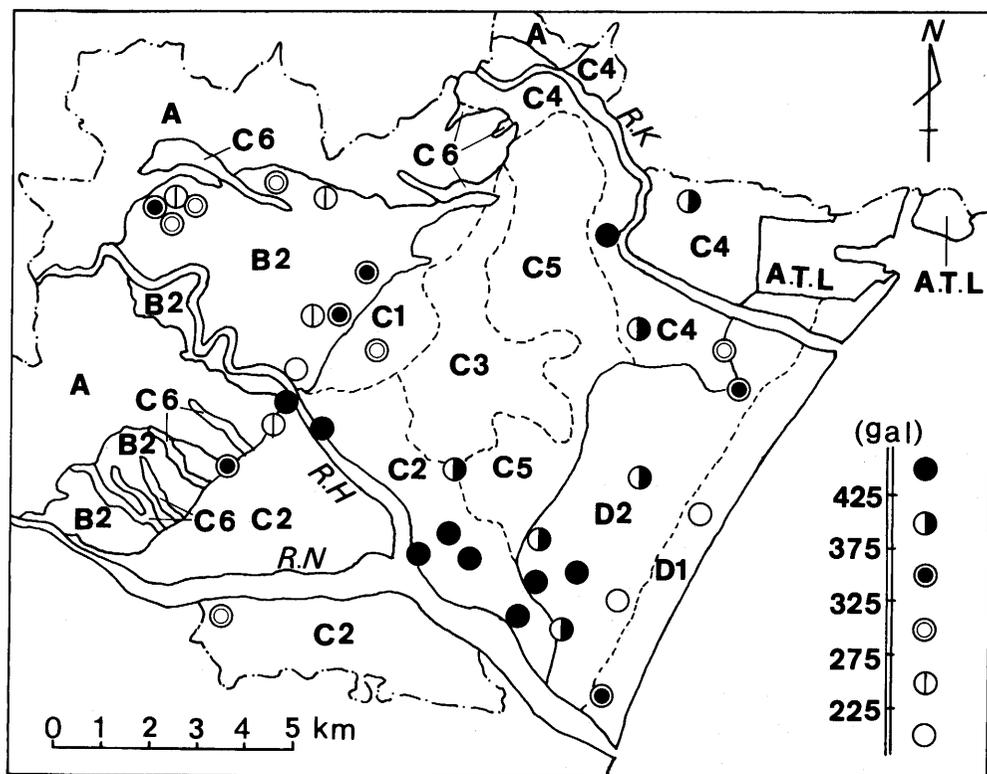
The authors estimated the maximum horizontal acceleration at many cemeteries in Sendai City (Fig. 1). The sizes of more than thirty gravestones were measured in each cemetery, about half of which had been overturned. Fig. 1 shows that while the maximum horizontal acceleration is large in the Hirosegawa-Natorigawa Lowland (C2), the Nana-kitadagawa Lowland (C4) and the Coastal Plain (D2), it is small on the Terrace Surface (B2), the Coastal Barrier (D1) and the Colluvial Slope (C1). It means that the maximum horizontal acceleration is much affected by the uppermost deposits in the Sendai Lowland.

Fig. 1 Topographic division of Sendai City and the maximum horizontal acceleration (Explanation of each region is shown in Table 1)
 R.N. : Natori River, R.H. : Hirosegawa River, R.K. : Nana-kitadagawa River, A.T.L. : Artificially transformed lowland (Oil plant is located)

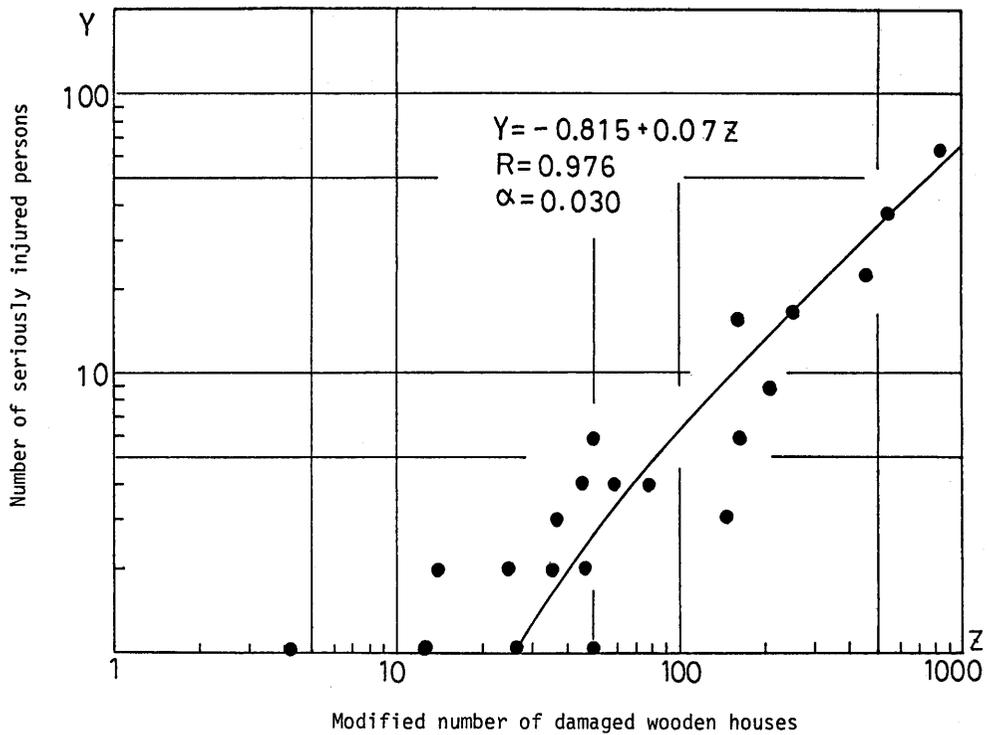
Fig. 2 shows the relationship between the number of the seriously injured (Y) and Z . Supposing that α is 0.30, the correlation coefficient (R) takes the maximum value of 0.976. Likewise, when α is 0.050, the correlation coefficient (R) between the number of the slightly injured (Y') and Z reaches 0.985, the maximum value (Fig. 3). The numbers of Z , Y and Y' are calculated for each topographic unit but some of large units were divided into two parts in Figs. 2 and 3.

Fig. 2 Relationship between modified number of damaged wooden houses and number of seriously injured persons

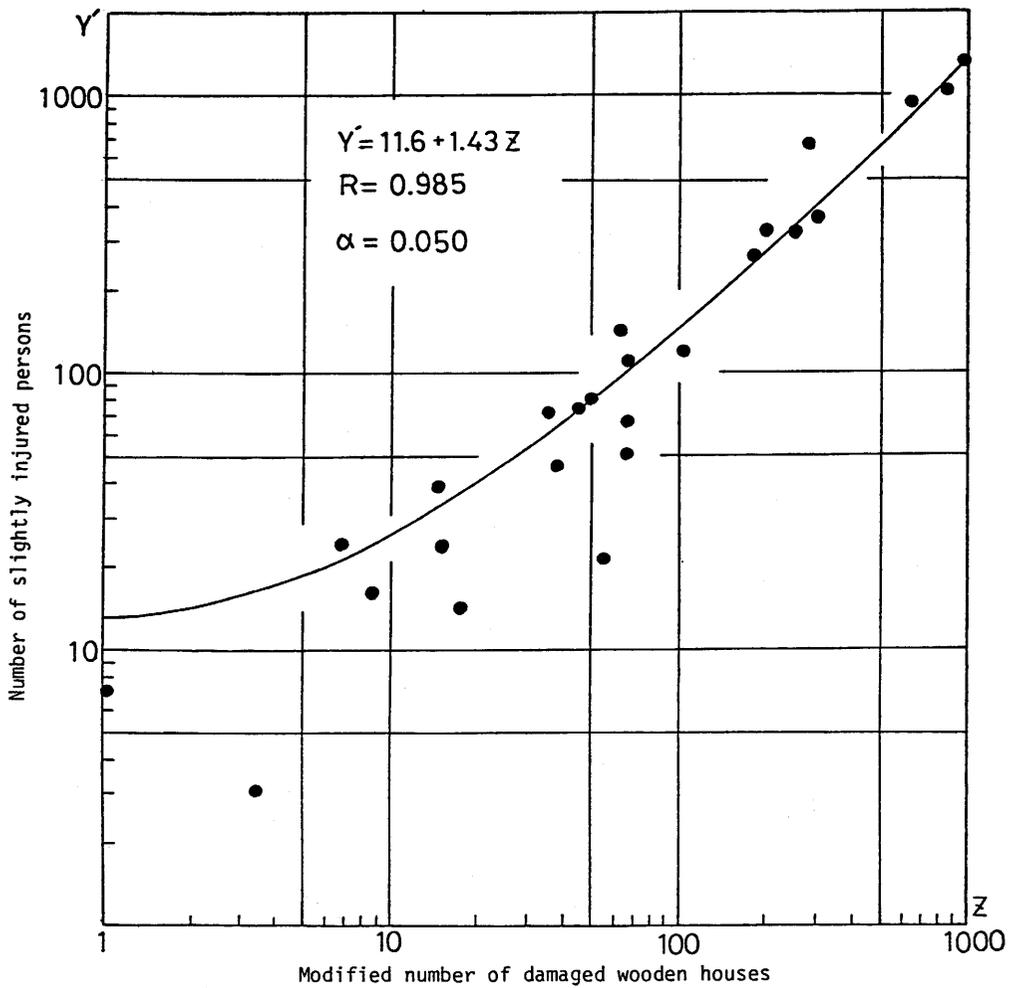
Fig. 3 Relationship between modified number of damaged wooden houses and number of slightly injured persons
