# Report on Damage of Industrial Facilities in the 1999 Kocaeli Earthquake, Turkey

Kohei Suzuki\*

## Abstract

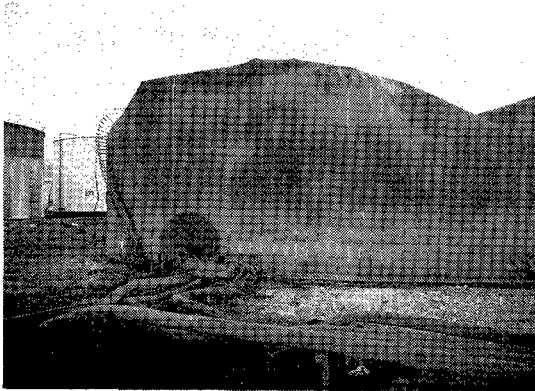
6 cylindrical tanks having floating roofs caught fire immediately after the earthquake. Out of 6 tanks, 4 middle size tanks has a diameter of 20-25 *m* and 2 small size tanks has a diameter of about 10 *m*. Naphtha in the middle size tanks were completely burned. Tanks were damaged as a result of thermal deformation. The estimated naphtha is about 36,000 ton. Fig.4 and 5 show the deformed state of burned tanks.

The fire in a naphtha tank farm was considered to be initiated by sparks created by bouncing of the floating roof against the inner walls of the tank during the earthquake. Sparks ignited the naphtha. There were 46 tanks with floating roofs and among them those of 30 tanks were damaged independent of the size of tanks. Most of tanks were constructed in the early 1960s according to the earthquake design code of California for a Level 4 ground shaking. In addition to cylindrical tanks, there were some spherical tanks in the plant. None of these was damaged. As seen in Fig.6, the piers and bracing of these spherical tanks shows no visible damage. Therefore, they should have had enough resistance strength against the ground shaking during the earthquake.

Fig.4 Burned Cylindrical Tank (1)

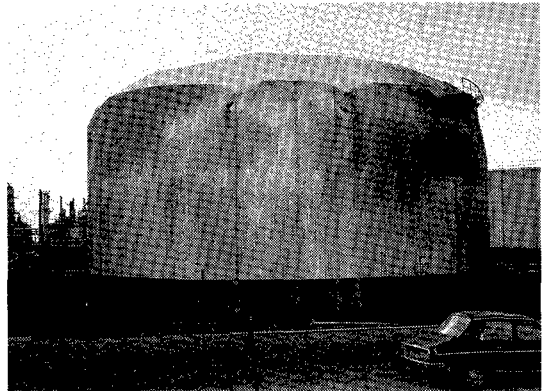
As seen in Fig.7, the upper part of a tank with a fixed roof near a burned tank was deformed as a result of thermal pressure caused by fire rather than sloshing.

Fig.7 Deformation of Cylindrical Tank with Fixed Roof

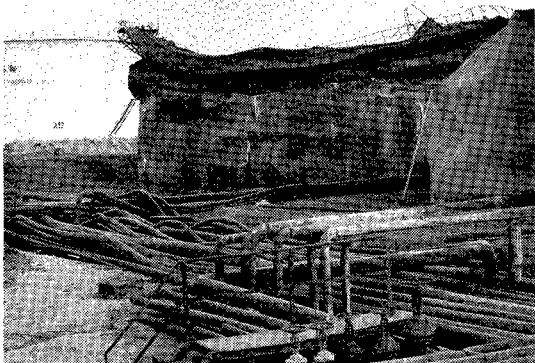
Fig.5 Burned Cylindrical Tank (2)

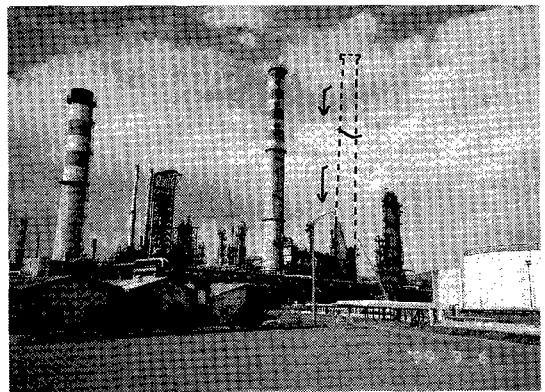
The collapse of one of stacks in the crude oil distillation unit caused fire also just after the earthquake. One of the collapsed stack parts directly hit an upper super heater unit having high temperature of more than 500 °C . The height of 5 stacks which were built in 1981 ranges from 90 *m* to 115 *m*. Fig.8 shows a collapsed stack together with undamaged stacks. Crumbled stack shown as Fig.9 was initially 105 *m* high. However, it is difficult to estimate that the main cause of the collapse of the stack is only resonant response to ground shaking since other stacks having similar height were undamaged. Investigators at TÜPRAS explained the main reason of collapse might be associated with material degradation of inner wall of the stuck as a result of corrosion due to alkali gases such as hydrogen sulfide gas. Fig.10 shows fired heater unit by getting the hit of collapsed stack. The fire of this unit extinguished at the night of August 17. While extinguishing the fire at this unit, the fire in the tank farm became very strong and unmanageable. Another part of collapsed stack hit the pipe-rack which was arranged near the damaged unit. Fig.11 demonstrates the damaged pipe and pipe-rack.

Fig.8 Collapsed Stack and Undamaged Stacks

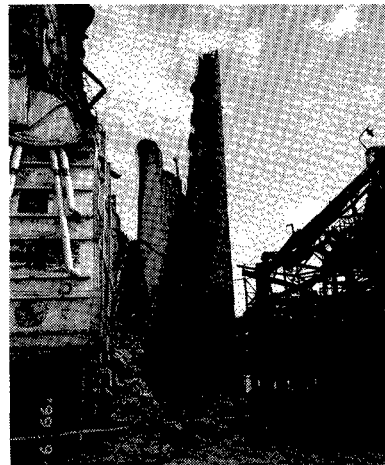
Fig.9 Crumbled Stack

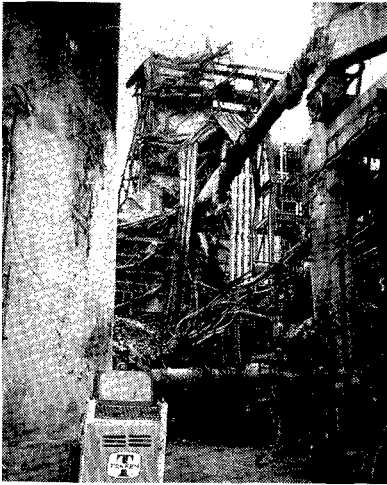
Fig.10 Damaged Oil Furnace Hit by the Collapsed Stack Part

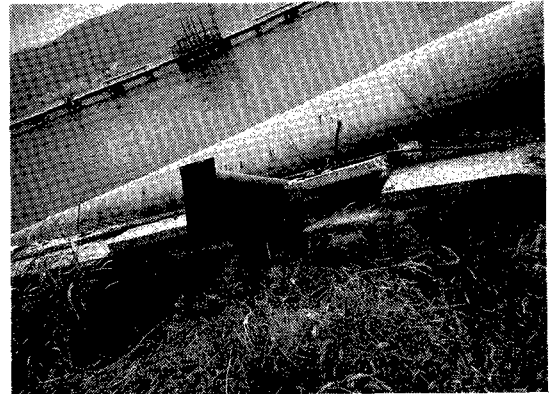
Fig.13 Tilted Pipe Support on the Embankment Wall

The pipes having a diameter of about 700 mm installed over a concrete embankment were fallen towards the sea-side as seen in Fig.12 for a length of 150 m due to the tilting of supporting device as in Fig.13. Nevertheless, the pipes got no serious failure such as breakage and rupture. As shown in Fig.14, there was no severe damage to pipings around the area near oil refineries except to those damaged by the fire shown as in Fig.15. However, some failures were observed at pipe joints in the area of sea side where the supporting structure somehow moved due to the earthquake as shown in Fig.16.

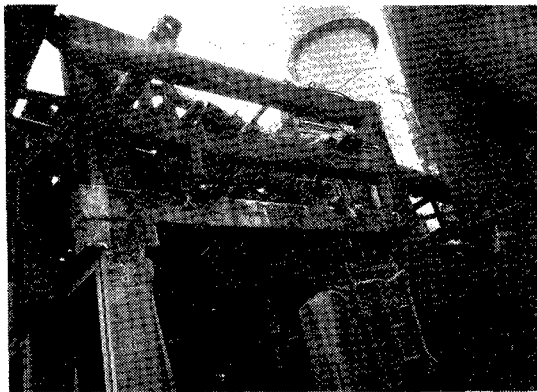
Fig.11 Damaged Piping and Pipe-support Structures Hit by the Collapsed Stack Part

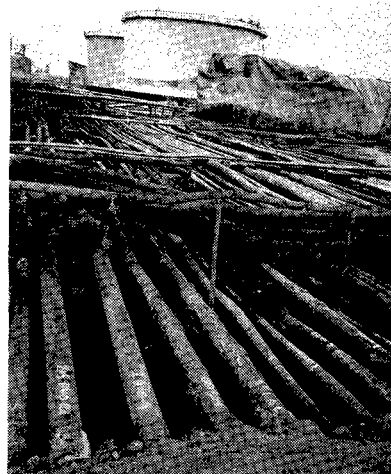
Fig.14 Damaged Pippings by the Tank Fire

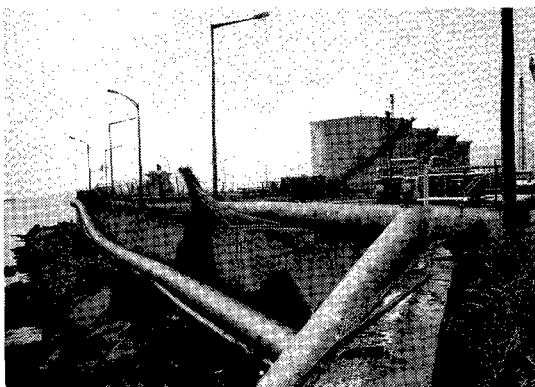
Fig.12 Piping Falling from the Embankment Wall

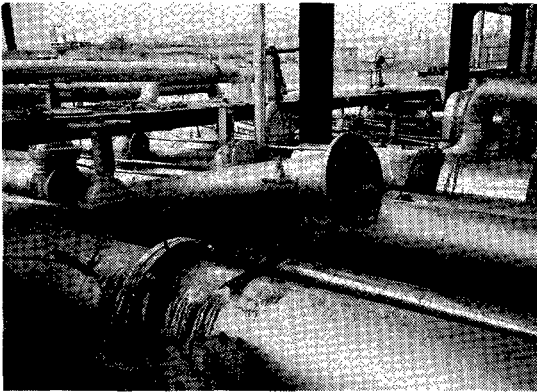
Fig.16 Damaged Pipe Joint due to the Axial Movement

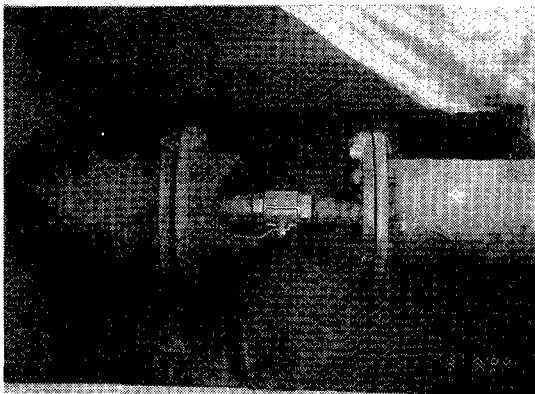
Since the ground breaks due to faulting pass through the north-east part of the plant, the floor and side-walls of press shop and welding shop ① in Fig.21, and welding shop ② were deformed. Nevertheless, this damage could not cause any obstruction to the production. Pipes for water, electricity and fire extinguishing were broken or damaged as a result of ground breaks. Water pipes had a diameter of 400 mm and made of concrete. Fire extinguishing pipes are steel and had a diameter of 200 mm. The pipes were ruptured at connections or valves in the

area ⑧ . Fig.22 and 23 show a mended pipe connection and damaged valves, respectively. The boiler for car drying after painting uses natural gas. No damage to the natural gas pipeline was reported. Among 30 buildings, two buildings with concrete roofs were only damaged. The damage was concentrated at the bottom and top connections of the columns. The roof was displaced about 10 *cm*. The side-walls of the factory is made of poly-uretan sheets and no brick clad walls are used. Some of windows in roof were fallen and plastering in walls were peeled off. In addition, some slight damage to steel structures was observed.

Fig.22 Repaired Embedded Piping Damaged at the Joint

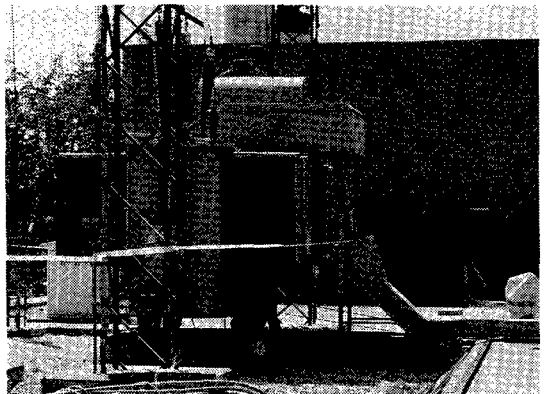
Out of 2 transformers located in ⑤ , one transformer was fallen as a result of the failure of its supports. Another one was not fallen, however, damaged at the leg as seen in Fig.24. Both transformers are put on rails. Anchors were used to restrain the movements of transformers during ground shaking. These anchors were pulled out of their concrete foundations and the transformers were displaced. 3 cylindrical tanks put horizontally were undamaged. On the

Fig.24 Damaged Transformer (Another one fallen off the supporting rail)

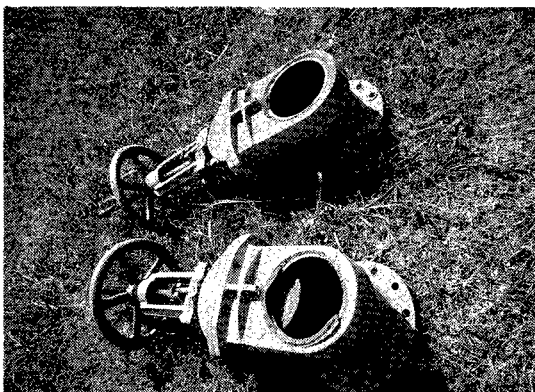
Fig.23 Broken Valves

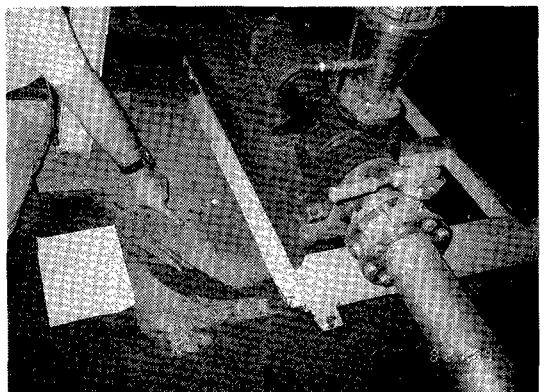
Fig.25 Sliding of Pump and Pipe

other hand, the cooling water tank installed horizontally slid 1 *m* and pipe connections were broken. Also, small pump with piping slid as shown in Fig.25. The ventilator (8 *ton*) in a 9 *m* high building ③ was fallen as a result of breakage of the pin of vibration-proof coilsprings as seen in Fig.26. The guide-rails of roof cranes (10~30 *ton*) with a 20 *m* span become 1~2 *cm* narrower. The parts on the racks were fallen. In addition, the hen-machine was displaced from its rails. In welding shop, the robot for welding was not damaged. However, some kinds of auto-manufacturing machines got tilting as shown in Fig.27.

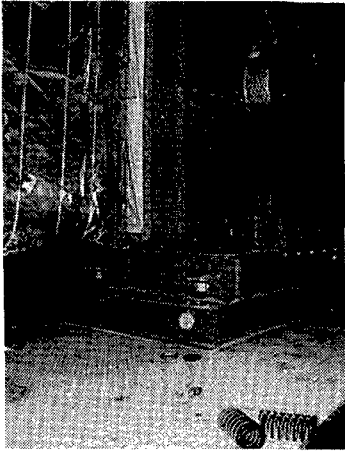
Fig.26 Fall of Large Blower due to the Breakage of Vibration-proof Springs

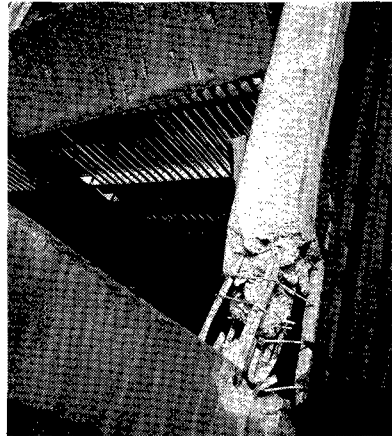
Fig.28 shows the damaged state of wooden cooling tower. Fig.29 shows the damaged columns of the reinforced concrete cooling tower. Pipes suspended to the jetty were fallen for several centimeters. However, they were already repaired at the time of the visit. The officials of this plant said they were more concerned with the housing of their workers since the damage to the plant was quite limited.

Fig.29 Damaged Support Column of Reinforced Concrete Structure for Colling Towers

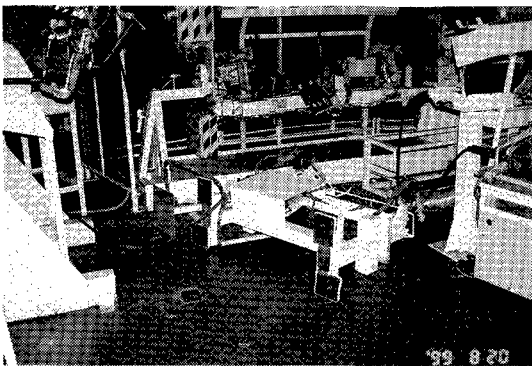
Fig.27 Tilting of Auto-manufacturing Machine

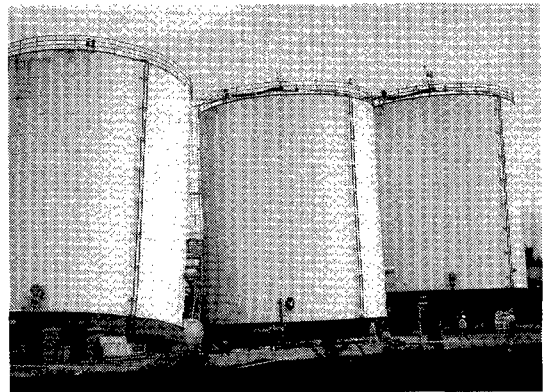
In Kosekoi near Izmit, a liquefied gas supplying company called HABAS is located. In this plant, there were cylindrical tanks for liquefied oxigen and nitrogen. These tanks were supported by reinforced concrete columns. Out of three tanks, the columns of the two tanks were collapsed due to earthquake and the tanks sank and inclined. These tanks were storing great amount of liquefied gas while the undamaged one was almost empty at the time of excitation. Fig.30 and 31 show the damaged state of the tanks.

Fig.30 Damaged Liquefied Gas Tanks(left and middle) and Undamaged Tank(right)

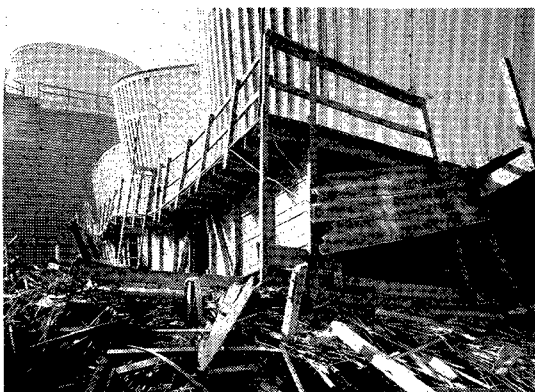
- (1) Wooden cooling tower structure was totally collapsed and several structure parts of the reinforced concrete cooling towers were damaged.
- (2) The jetty of loading-unloading facility of this plant was damaged due to the movement of wharf.
- (3) Embedded pipes along the seashore were damaged.

Fig.28 Collapsed Wooden Cooling Tower Structure

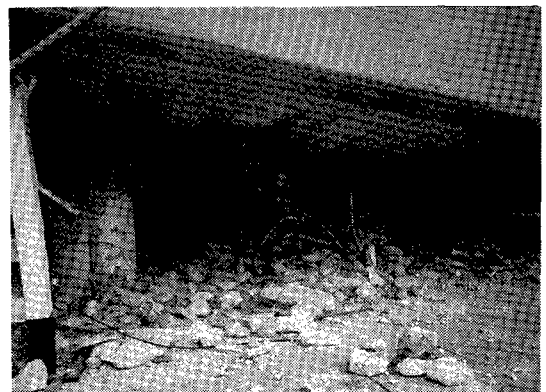
Fig.31 Close-up View of Broken Support Columns of Vertical Tank
