# Systematic Photo-Geomorphological Analysis of Land Deformation due to Earthquake

Takamasa NAKANO

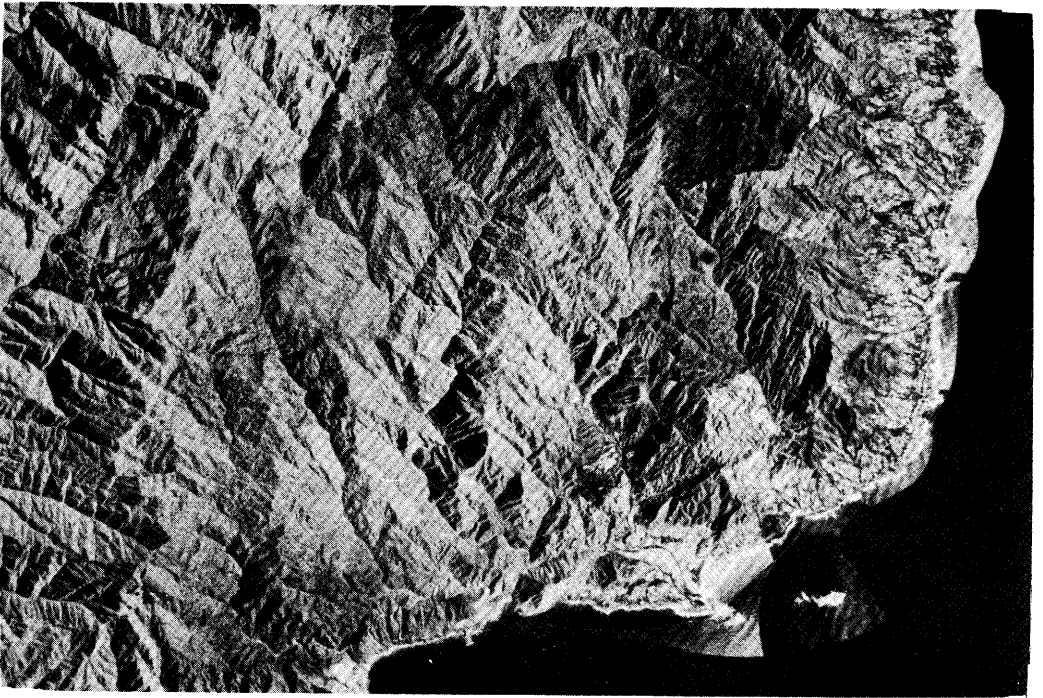
Plate 2    Linearments of Yakushima Island.  
          (Asia Aero Survey Co., Ltd.)

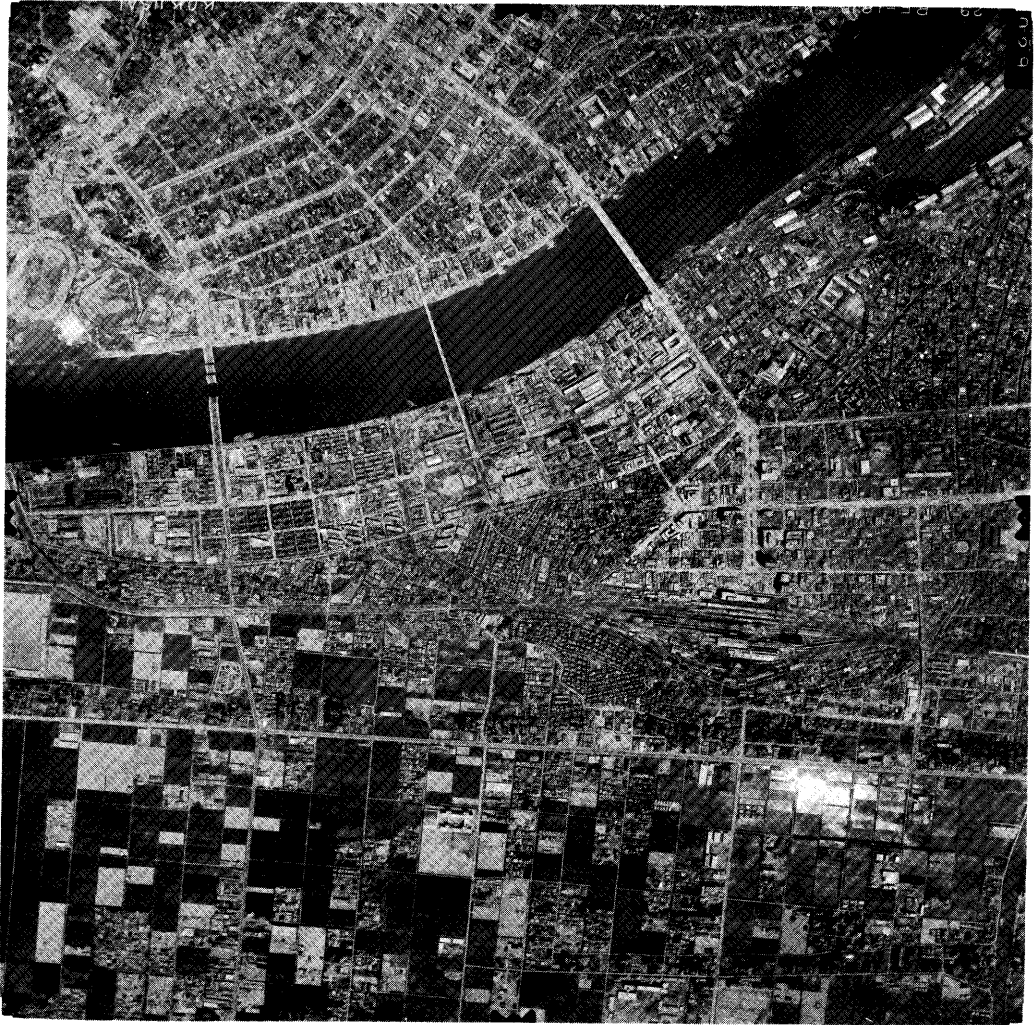
Plate 3    Earthquake disasters due to the  
          Niigata Earthquake in 1964.  
          (Kokusai Aero Survey Co., Ltd.)

The Niigata Earthquake, which occurred in June 16th of 1964, was characterized by land deformations, flood disasters due to inundation of the area below sea level, damage to constructions on unconsolidated and soft sediments and fire of oil tanks. Land deformations and damage due to quick sand phenomena were mostly in the area of former river courses composed of unconsolidated and soft sediments, and the area inundated coincided exactly with the area mentioned above. That is earthquake damage was concentrated in the limited area of soft sediments. Consequently, analyses of earthquake damage should
