# Report on Damage of Industrial Facilities in the 1999 Kocaeli Earthquake, Turkey

Kohei Suzuki\*

## Abstract

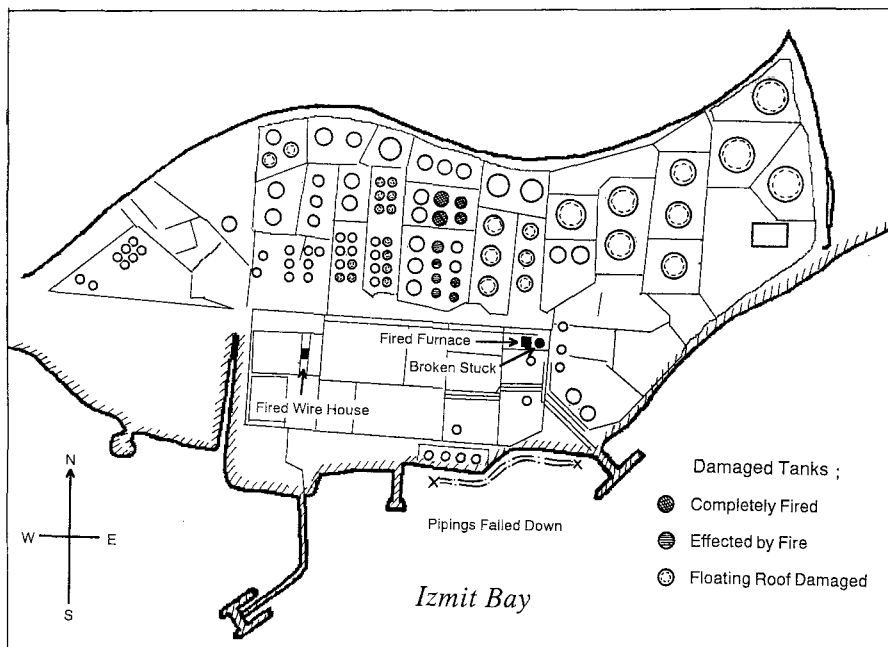
Fig.3 Plan View of Izmit Refinery and Location of Damaged Facilities

unit, one naphtha sweetening unit and related utility units. The products are naphtha, gasoline, jet-oil and kerosene and others. The 860,000-ton crude oil is stored in 14 large cylindrical tanks and 840,000-ton semi-products are stored in 86 middle and small size cylindrical tanks. Fig.3 shows an outline of the refinery in which location of the fired and damaged tanks are described.

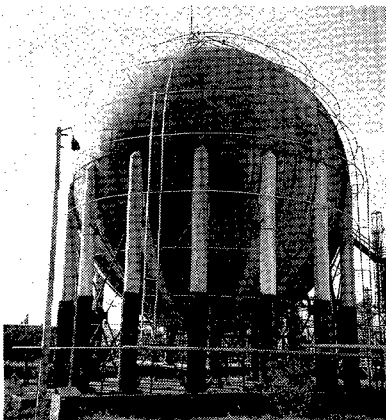
Fig.6 Undamaged Spherical Tank

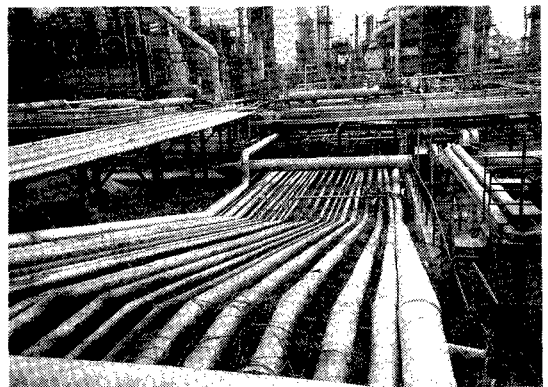
Fig.15 Completely Undamaged Pippings

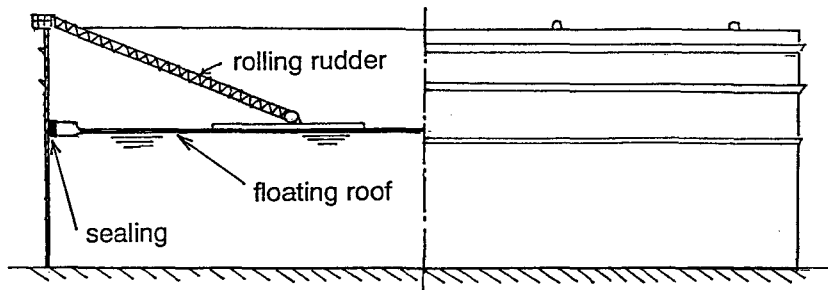
Fig.19 shows a rough description of cross section of cylindrical tank with floating roof. Some kinds of sealing devices are installed between outer edge of the floating roof and inner wall of the tank. In Fig.20, typical examples of metallic seal and rubber envelope seal are illustrated. Currently, for almost all tanks rubber envelope type of sealing are introduced in

Fig.19 Cross Section of Cylindrical Tank with Floating Roof

order to avoid the spark due to the roof bouncing against the tank wall. However, in 1960s when the tanks in the Izmit firm were constructed, metallic sealings were still introduced. Therefore, it is expected that big sloshing behavior could ignite the naphtha by sparks resulting from the bouncing of the roofs against the walls caused by the seismic excitation.

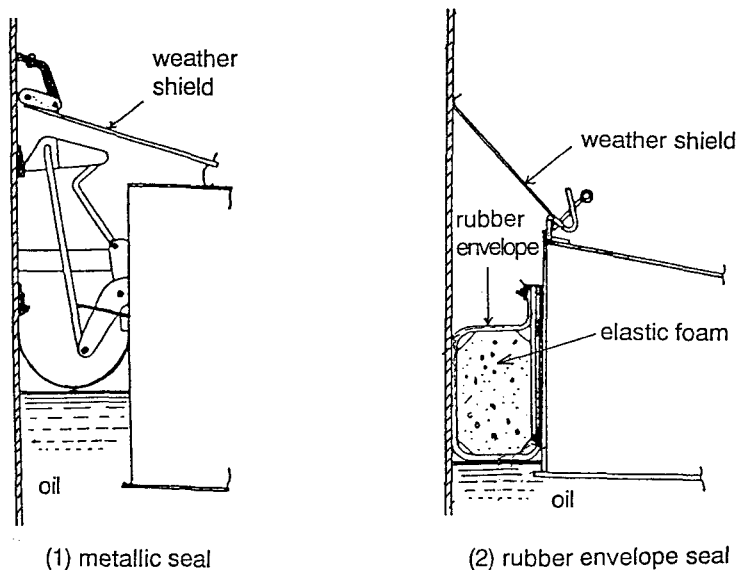
Fig.20 Mechanism of Metallic Seal and Rubber Envelope Seal

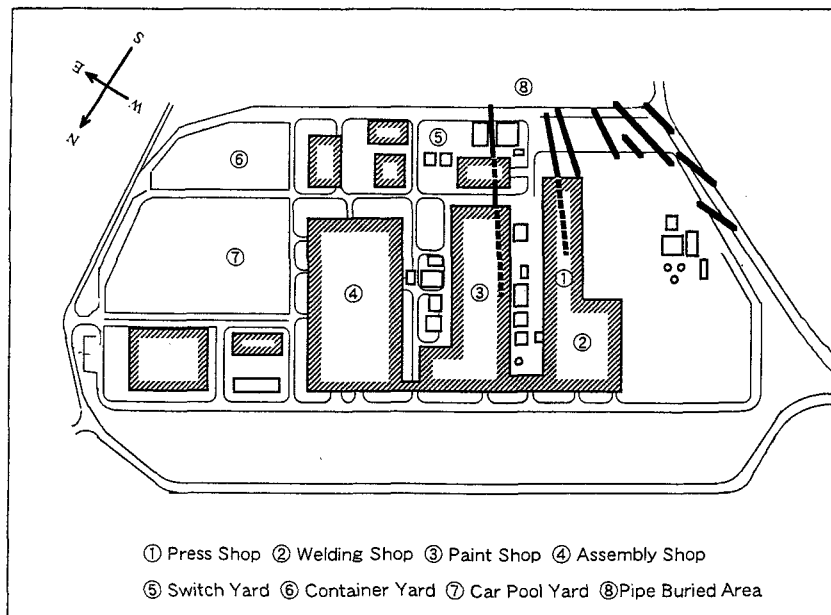
Fig.21 Plan View of TOYATA-SA Automobile Factory

Since the ground breaks due to faulting pass through the north-east part of the plant, the floor and side-walls of press shop and welding shop ① in Fig.21, and welding shop ② were deformed. Nevertheless, this damage could not cause any obstruction to the production. Pipes for water, electricity and fire extinguishing were broken or damaged as a result of ground breaks. Water pipes had a diameter of 400 mm and made of concrete. Fire extinguishing pipes are steel and had a diameter of 200 mm. The pipes were ruptured at connections or valves in the
